PLOT 45 EXTERNAL

Issue Report

Castle Meadows Estate,
Plot 45,
Stirling,
Stirling,
FK8 1FQ,
United Kingdom

28/12/2024

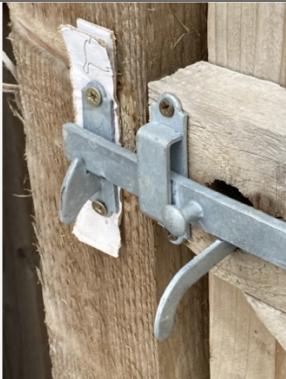
Gate Lock

The latch is not aligned to the post, requires to be adjusted and / or replaced to catch correctly.

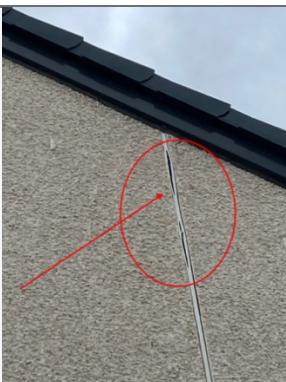
Pebble Dash expansion strips

Pebble dash expansion stops have cracked, required to be replaced or possible new mastic sealant as a replacement

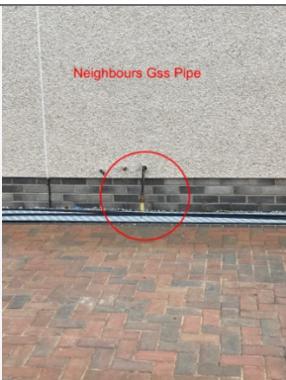
Gas pipe

Query - why is my Gas Pipe not penetrating into the property straight? Every other property on-site is straight up.

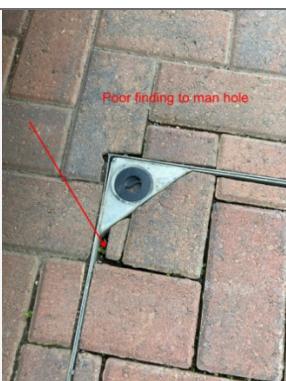
Mono block

Driveway mono block required remedial work to straighten up the block works

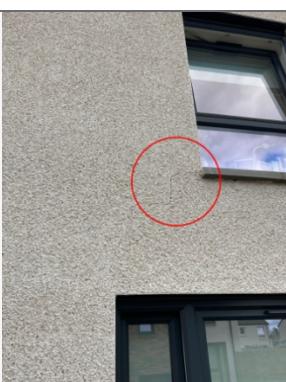
Pebble Dash

Cracks appearing in pebble dash requires investigation given the rumours on-site with subsidence

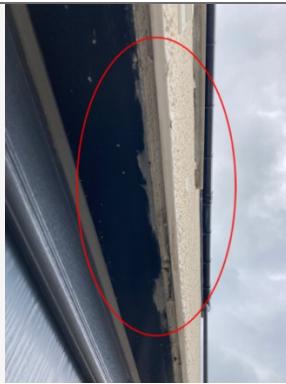
Excessive mortar requires to be cleaned up

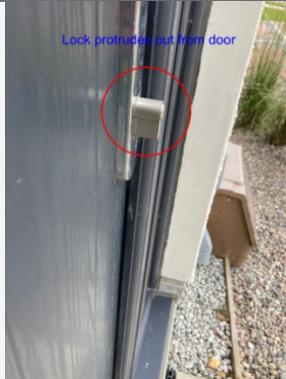
Front Door

Front door lock barrel protrudes out and is a safety issue and requires to be replaced.

The front door handle should be a Matt finish as requested

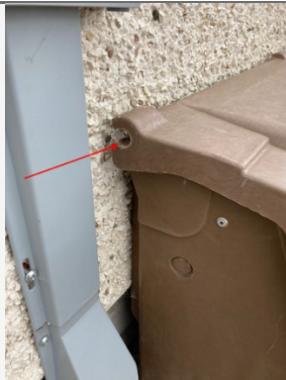
Gas Meter Box

Gas meter box to be replaced as broken and cannot lock

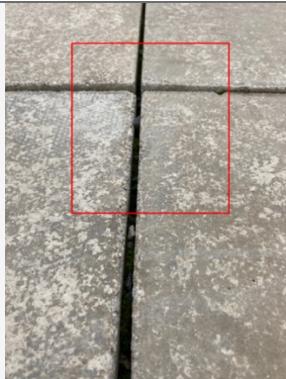
Paving Slabs at front door

Paving slabs have no weed proof membrane as required.

Paving slabs are not flat and evenly spaced, required to be lifted and replaced after weed membrane has been applied

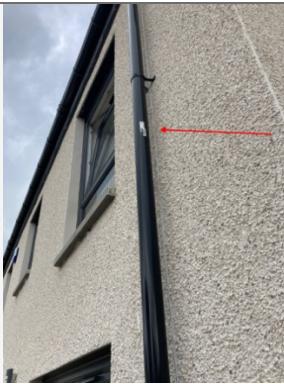
Name
Downpipe
Issue Status - Raised
Description
Remove sticker from downpipe
Location - External

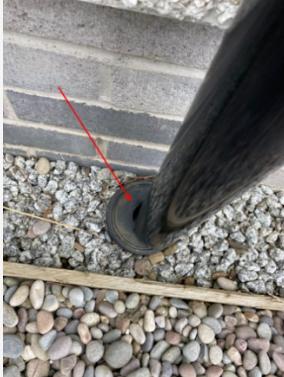
Name
Downpipe
Issue Status - Raised
Description
Downpipe requires to be flush to connect into drain away
Location - External

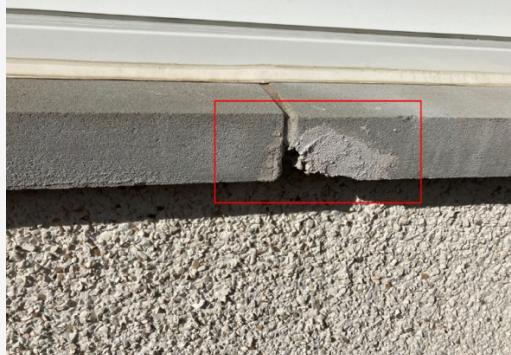
Name
Kitchen Window sill
Issue Status - Raised
Required Trade - Plastic Surgeon
Description
Plastic surgeon to repair
Location - External
